**DEPARTMENT OF TRANSPORTATION****DIVISION OF ENGINEERING SERVICES**

Quality Assurance and Source Inspection

Contract #: 04-0120F4Cty: SF/ALA Rte: 80 PM: 13.2/13.9File #: 1.28**WELDING INSPECTION REPORT****Resident Engineer:**Pursell, Gary**Address:** 333 Burma Road**City:** Oakland, CA 94607**Report No:** WIR-012970**Date Inspected:** 06-Apr-2010**Project Name:** SAS Superstructure**OSM Arrival Time:** 630**Prime Contractor:** American Bridge/Fluor Enterprises, a JV**OSM Departure Time:** 1500**Contractor:** American Bridge/Fluor Enterprises, a JV**Location:** Job Site

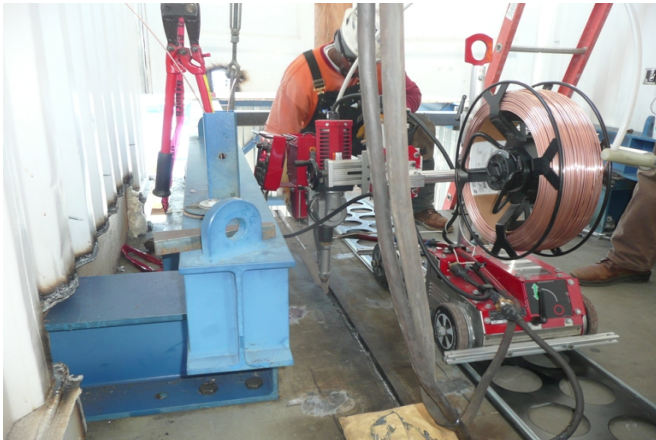
The QA Inspector randomly observed the ABF welders Jeremy Doleman and Rory Hogan performing flux cored arc welding the in 4G position at the above identified location. The QA Inspector noted ABF welders were welding the final 3 meters of the FCAW back weld in the above identified weld segment. The QA Inspector randomly observed the induction heating blankets were previously installed and turned on, maintaining the minimum required preheat of 150°F. The QA Inspector noted the SE QC inspector Mike Johnson was on site monitoring and recording the in process production welding. The QA Inspector randomly observed the FCAW parameters and they appeared to be in general compliance with ABF-WPS-3042A-1. The QA Inspector noted the FCAW cover pass was completed on the QA Inspectors shift.
